PROBE TIPS #11

A Technical Bulletin For Probing Applications

Probe Mark Analysis

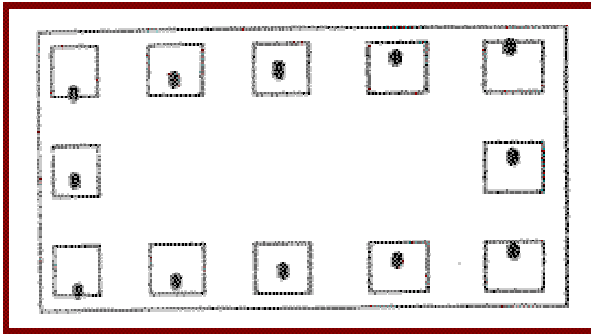
X- Y alignment is perhaps one of the most common problems. It is the most visibly obvious problem and is very simple to correct. Probe placement should always aim to hit the approximate center of the test pad after applying overtravel. When examining a device which has been probed, it is easy to spot probe misalignment since the resulting scrub mark will be visibly off center on the test pad. A common technique used by some manufacturers is to design into the test pad a circular target, which represents the tolerance range within which the mark must hit. Such a technique forces the establishment of a target specification and speeds up the visible QC process. If alignment is found to be visibly off center due to the amount of overdrive and the size of the pad, the target specification was not met. If such misalignment is found, the probe could be scrubbing into the glassivation and quickly contaminating the probe tip, contributing to decreased probe tip life. Worst case scenario, the glassivation is broken and the part is scrapped. Alignment problems could indicate a faulty setup procedure or a careless/ inexperienced operator. The most common alignment setup error is theta adjustment (rotational error). This is indicated when the probe marks on one side of the die are toward the outside edge of the pad and the other side of the die has the probe marks toward the inside of the die.

Extra care taken to align the probes will contribute to reduce setup costs, longer probe life and higher yield through faster setup and improved contact.

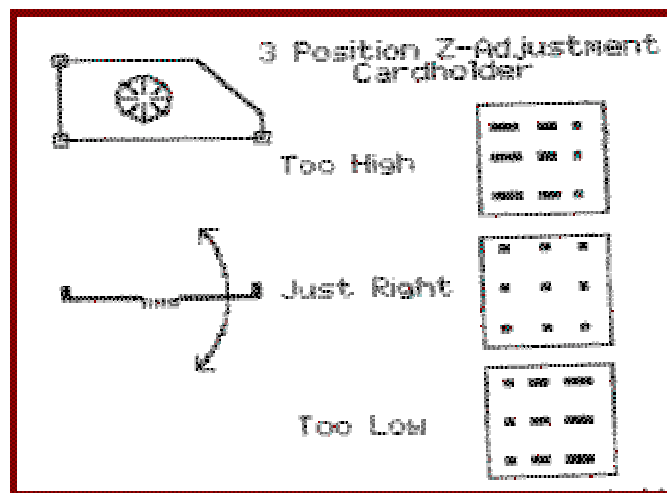
The cardholder in the prober should be calibrated to be flat and parallel to the top surface of the chuck. This will insure the simultaneous contact of all the probe tips. If the cardholder or chuck is out of plane in relation to the other, probes on one side of the die will touch down before the other side of the die. The lower probes will scrub more than the higher probes and the problem can be easily identified with visual QC. Probers that are designed with three position z-adjustment cardholders (such as Electroglass 1034) should be checked and calibrated regularly. These probers have only one z adjustment position where the table is flat and parallel to the device chuck and lead screw axis. In the example illustrated below only one position of the table provides uniform probe marks.

When the table is not adjusted properly, some of the probes are lower on one side of the device and higher on the other. The lower probes contact before the high probes and produce a longer scrub mark. Similar results occur if the device chuck is not parallel to the cardholder and lead screw axis.

Good system planarity implies that the prober (or device handler for laser trim systems) is checked regularly as part of a routine preventative maintenance program. This will insure that the cardholder and device chuck are flat and parallel to an established reference plane (usually the lead screw axis or air-bearing surface of the prober).
