PROBE TIPS #11

A Technical Bulletin For Probing Applications

Probe Mark Analysis

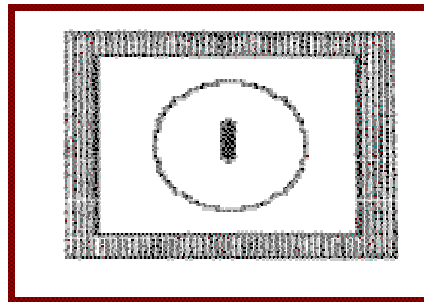
Probe marks are the "foot Prints" left behind by the probe tips after contact with the test pad. Probe marks become the evidence to provide clues to a wide variety of probing difficulties. Careful visual analysis of the marks can assure quality control or point to potential trouble in need of corrective action.
